# **Overview of the Third Quarter 2009 Surveillance and Maintenance Report for the LM Rocky Flats Site**

# Pond Operations – Third Quarter 2009

# Hydrologic Data – Third Quarter 2009

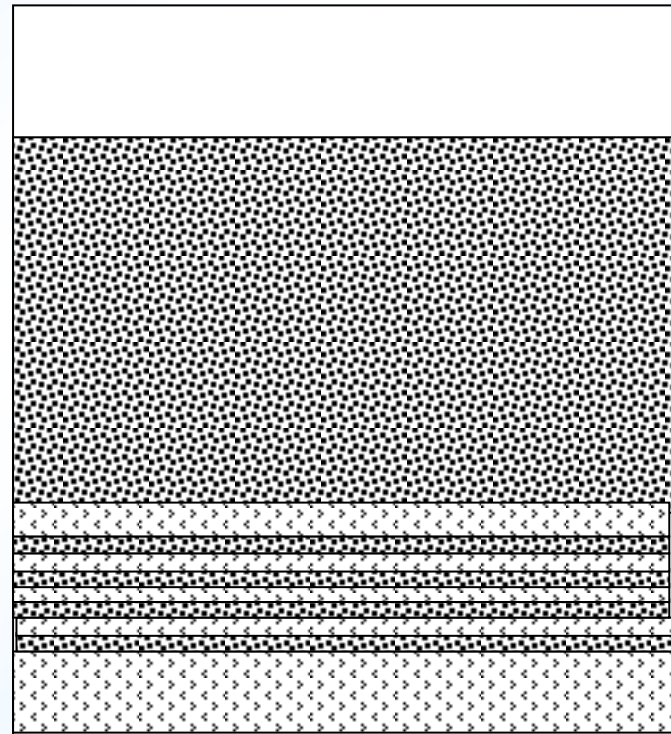
New media design

- Addressed short-circuiting and improved treatment effectiveness
  - Redesigned media
  - Used improved distribution gallery design
  - Changed primary operating configuration
- Prepared for next media replacement
  - Installed liner around inside of cell so media will not adhere to cell walls (in the past, has required jackhammer to remove)
- Reduced long-term maintenance needs
  - Eliminated buried valves (can cause problems; SPPTS in 2006)
  - Installed new flow-control vault directly between cells (easy access, eliminates pipe “spaghetti” that can lead to clogging)
  - Most pipes are now inside pipe liners; if clogging develops, can easily replace during media replacement without excavating
